DEPARTMENT OF TRANSPORTATION**DIVISION OF ENGINEERING SERVICES**

Quality Assurance and Source Inspection

Contract #: 04-0120F4Cty: SF/ALA Rte: 80 PM: 13.2/13.9File #: 1.28**WELDING INSPECTION REPORT****Resident Engineer:**Siegenthaler, Peter**Address:** 333 Burma Road**City:** Oakland, CA 94607**Report No:** WIR-016931**Date Inspected:** 22-Sep-2010**Project Name:** SAS Superstructure**OSM Arrival Time:** 630**Prime Contractor:** American Bridge/Fluor Enterprises, a JV**OSM Departure Time:** 1500**Contractor:** American Bridge/Fluor Enterprises, a JV**Location:** Job Site**CWI Name:** See below**CWI Present:** Yes No**Inspected CWI report:** Yes No N/A**Rod Oven in Use:** Yes No N/A**Electrode to specification:** Yes No N/A**Weld Procedures Followed:** Yes No N/A**Qualified Welders:** Yes No N/A**Verified Joint Fit-up:** Yes No N/A**Approved Drawings:** Yes No N/A**Approved WPS:** Yes No N/A**Delayed / Cancelled:** Yes No N/A**Bridge No:** 34-0006**Component:** SAS OBG**Summary of Items Observed:**

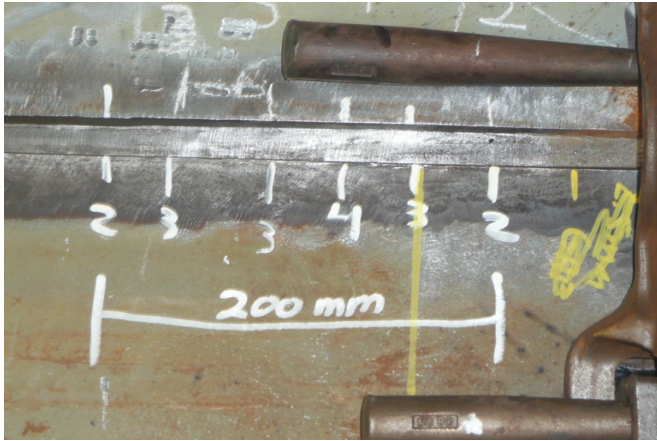
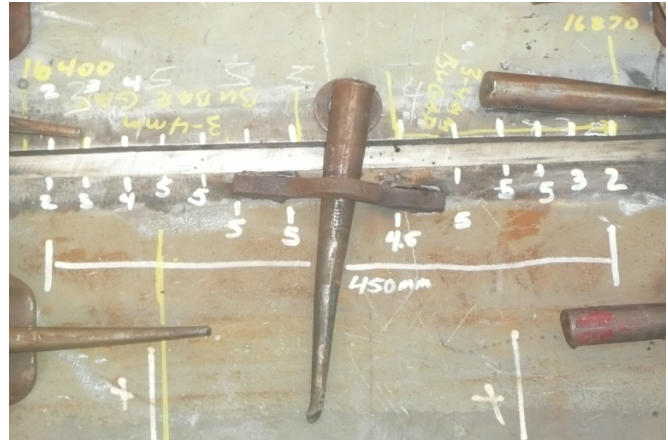
The QA Inspector randomly observed the ABF welder identified as Hua Qiang Huang performing FCAW root/fill/cover passes at the that 300mm of the weld segment. The QA Inspector randomly observed and noted no weld tabs or runoff tabs were being utilized on the weld joint. The QA inspector noted the ABF welder was depositing weld material 100% welded out complete on the last 300mm of the weld joint prior to performing the

FCAW full length tack weld. The QA Inspector noted the ABF welder identified as James Zhen was performing the same FCAW root/fill/cover in the weld segment A1. The QA Inspector randomly observed the SE QC Inspector Tony Sherwood was on site monitoring the in process FCAW. The QA Inspector noted the 300mm at the ends of both of the above weld segments were completed on this date.
